Technical Report REMR-CS-53  
April 1997

*Repair, Evaluation, Maintenance, and Rehabilitation Research Program*

# **Applications of Roller-Compacted Concrete in Rehabilitation and Replacement of Hydraulic Structures**

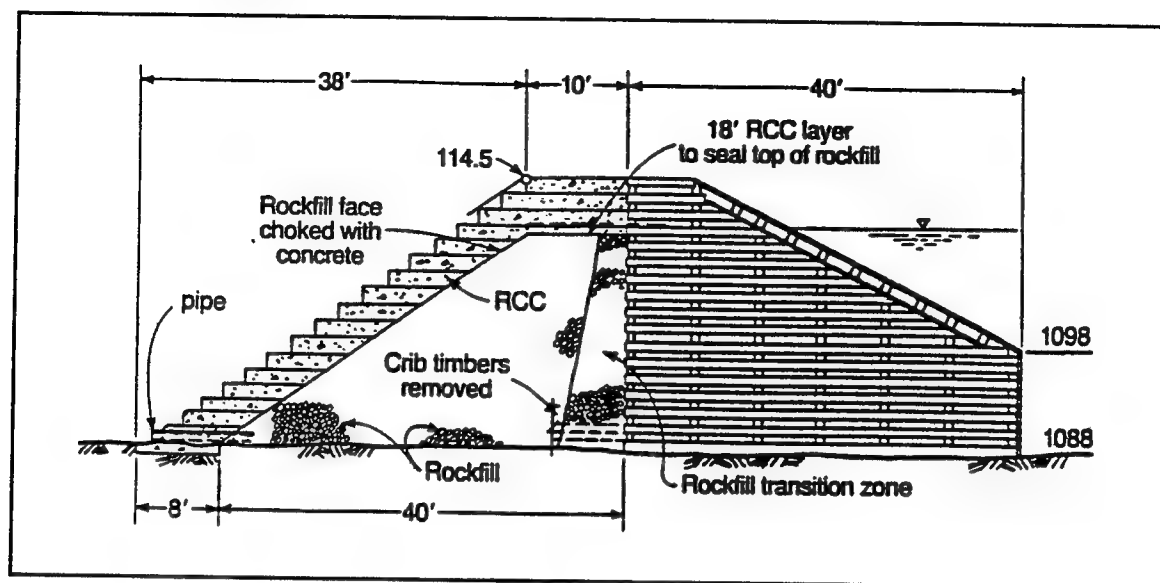
In 1976 power generation had to be suspended because of deterioration of several of the steel and concrete trestles that support the flume, portions of the flume, and the downstream face of the timber crib dam. Rehabilitation began in 1980. Because of its historical significance and uniqueness, the flume was rebuilt of wood supported by concrete footings. Riprap was placed on the downstream face of the rock-fill timber crib dam. After flash floods washed out the riprap four times, the Tennessee Valley Authority (TVA) decided to place RCC over the riprap (Hansen 1989b). Approximately 3,440 cu m (4,500 cu yd) of RCC was placed in 2.4-m- (8-ft-) wide, 0.3-m- (1-ft-) thick lifts over the riprap that had

Figure 1. Cross section showing rehabilitation plan for Ocoee Dam. (Multiply feet by 0.3048 to obtain metres)

been choked with concrete to produce a 1.54H:1.0V downstream slope (Figure 1).

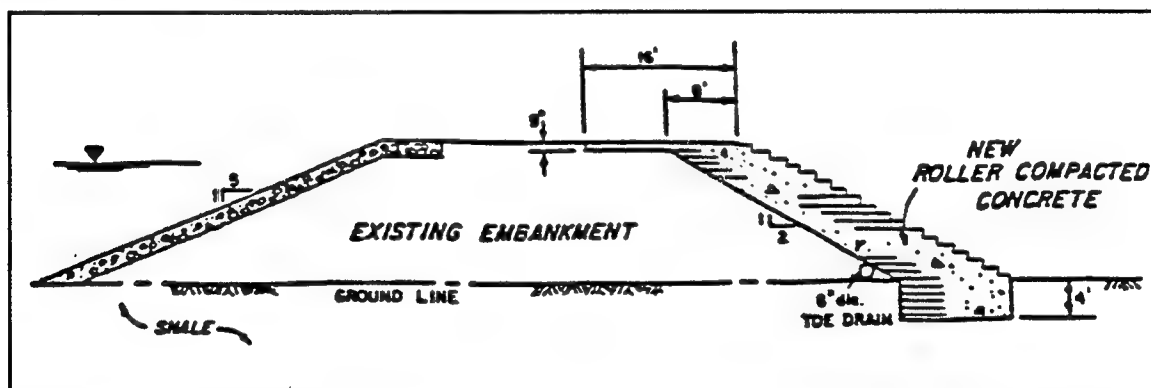
The state dam safety department placed the dam in the high-hazard category because of the inadequacy of the spillway and the increased development downstream of the dam (*RCC Newsletter* 1986). The country club was instructed to draw down the level of the reservoir; however, lowering the water level detracted from the appearance of the golf course. Country club officials chose to widen the spillway so it could pass the PMF (Hansen 1993).

Figure 5. Cross section of modified spillway, Brownwood Country Club Dam (courtesy of Reeves 1985, ASCE). (Multiply inches by 25.4 to obtain millimetres and feet by 0.3048 to obtain metres)

Options considered for increasing the spillway included excavating the right abutment, constructing a reinforced concrete spillway next to the existing spillway, or constructing the spillway with RCC. An RCC spillway was chosen (Figure 5) because it would have the lowest total cost and would require the least construction time (Morsman, Lawler, and Seimears 1985). This was the initial application of RCC to rehabilitate an existing embankment dam.

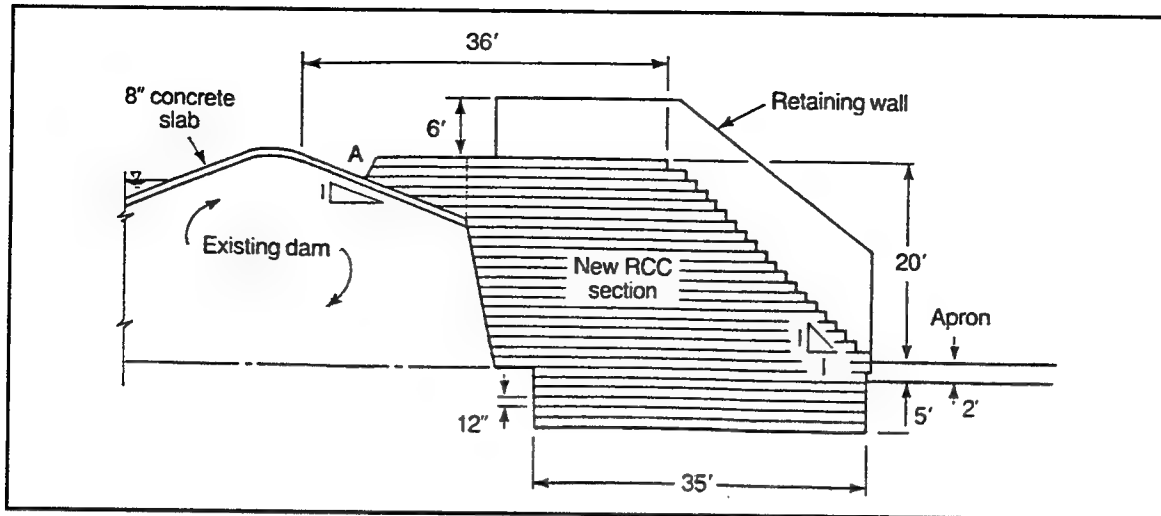
The dam was overtopped by 1.2 m (4 ft) in June 1981, when it sustained some damage. It was overtopped again in October 1982 by 1.4 m (4.5 ft); this time damage was more severe. Then on New Year's Eve 1984, the dam was overtopped by 3.0 m (10 ft). Damage included a loss of about 40 percent of the concrete shell over the service spillway and about one-half of the downstream embankment, severe concrete cracking in the emergency spillway, loss of filter material, and erosion in both abutments (Figure 8). The clay core was eroded to bedrock (Smith 1986).

Figure 9. Plan for RCC gravity buttress, Kerrville Ponding Dam (courtesy of Hansen and France 1986). (Multiply inches by 25.4 to obtain millimetres and feet by 0.3048 to obtain metres)

Several alternatives, including repair of the existing structure, were evaluated, but design engineers and consultants determined the fastest and most economical solution was to construct a new RCC section on the downstream embankment (Figure 9).

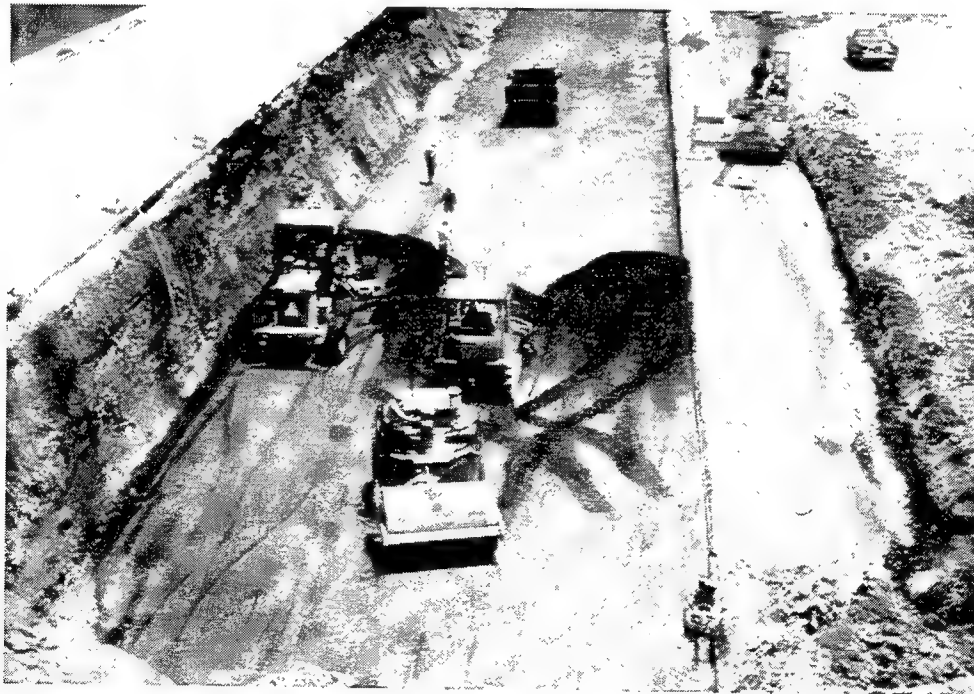
Figure 10. RCC placing and compaction, Kerrville Ponding Dam

In preparation for the RCC, the downstream portion of the embankment was removed; the undamaged upstream portion served as a cofferdam during construction of the RCC section (Figure 10). The RCC was placed in 0.3-m- (1-ft-) thick lifts, beginning on the foundation rock against the near-vertical face of the embankment. A sand-cement mortar was brushed on each lift as a bonding agent. RCC placement began in June 1985 and was completed 3 months later. Approximately 16,820 cu m (22,000 cu yd) of RCC was used in the project (Hansen and France 1986). Cost of the repairs, including engineering, construction, and stabilizing the remaining portions of the original dam, was between \$3 and \$3.5 million (Smith 1986).

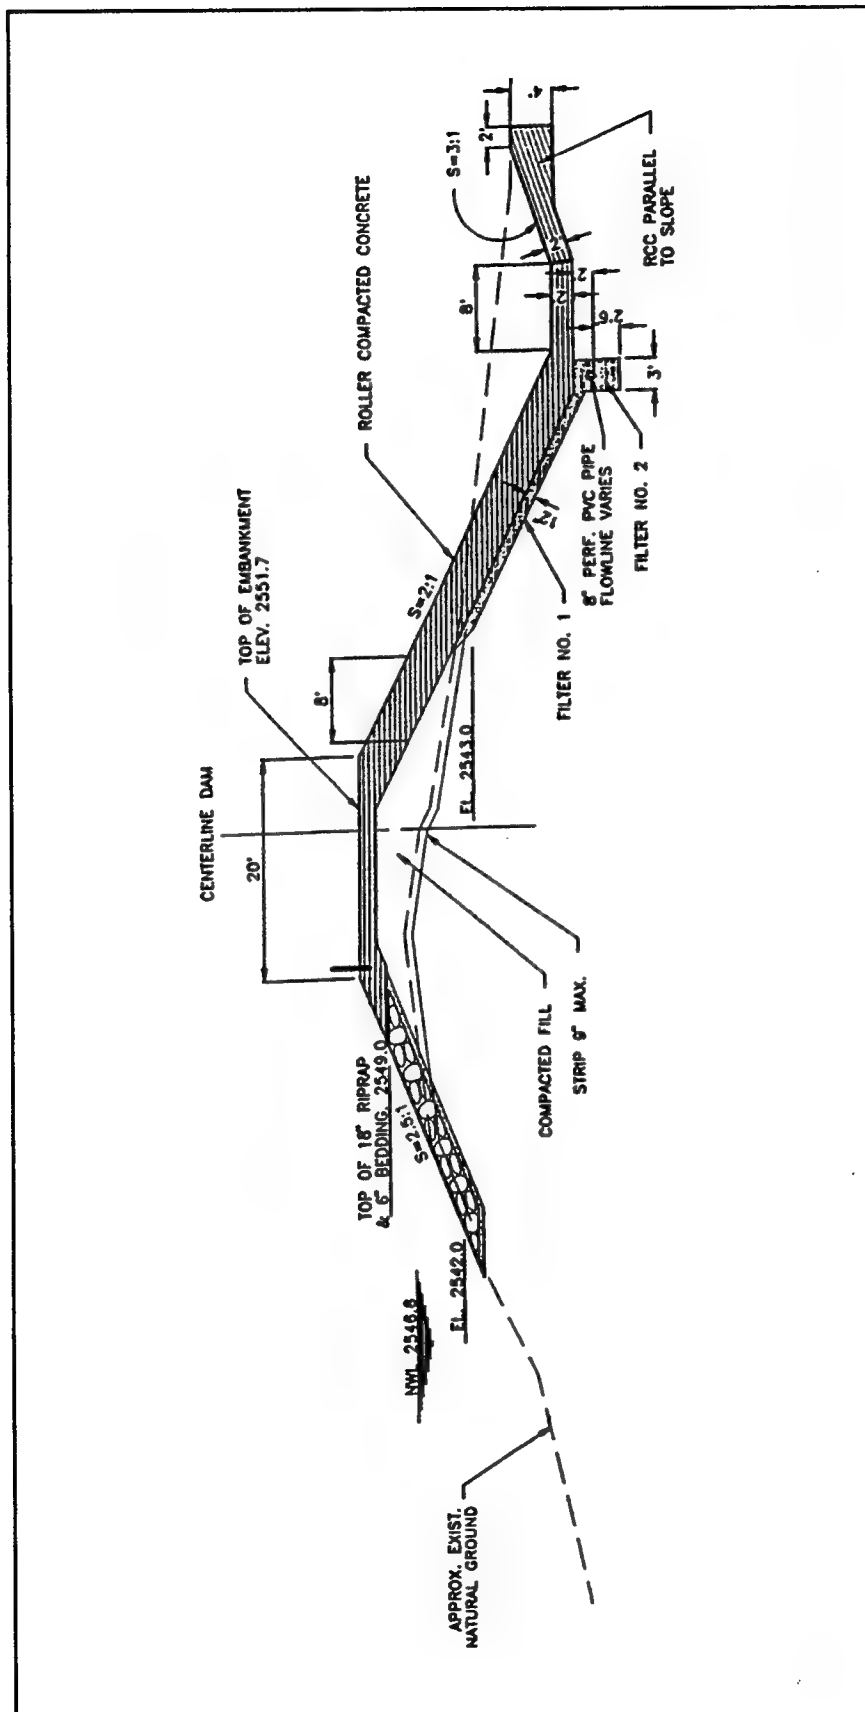
A primary consideration in the use of RCC with an embankment dam is how much the subgrade and foundation will settle. Consolidation tests indicated the maximum settlement after rehabilitation of Comanche Trail Dam would be about 25 mm (1 in.). This amount was not considered significant, so plans to place RCC on the crest, downstream embankment, and in the spillway proceeded (Figure 26).

Figure 26. Plan for placing RCC on Comanche Trail Lake Dam (courtesy of Lemons, King, and Rutledge 1990, ASDSO). (Multiply inches by 25.4 to obtain millimetres and feet by 0.3048 to obtain metres)

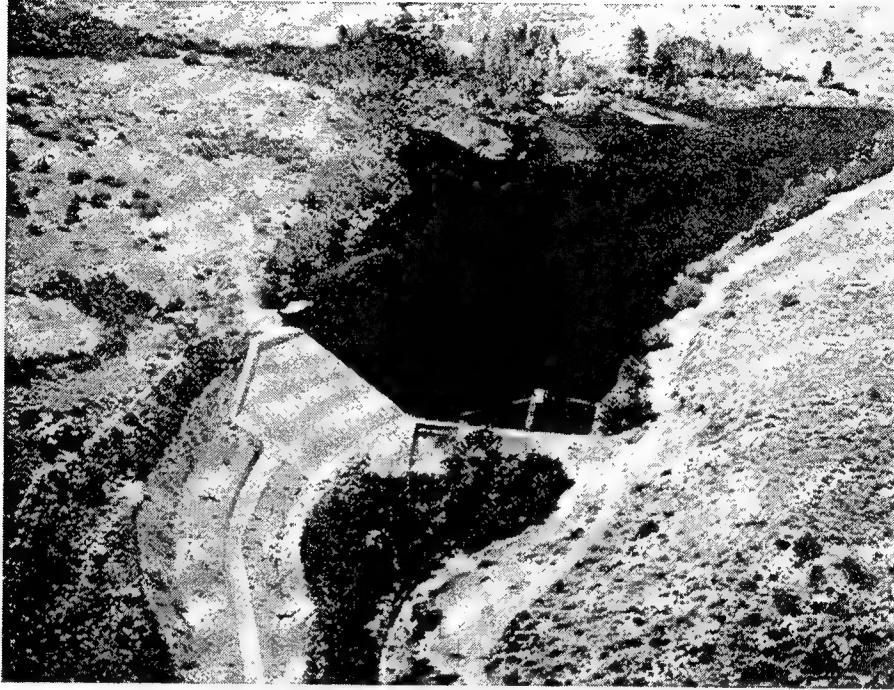
Figure 28. Completed RCC spillway at Bishop Intake No. 2 (courtesy of Throckmorton and Knarr 1991, ASCE)

The RCC spillway alternative was selected because it was the most economical. The design included constructing a spillway chute on the right portion of the dam and armorplating the crest and downstream slope with RCC to provide protection from erosion in case of overtopping. The spillway chute is about 61 m (200 ft) wide and 3 m (9 ft) deep). A reinforced concrete ogee weir extends across the width of the chute. The top portion of the dam is covered with a 0.6-m- (2-ft-) thick RCC slab, and the downstream face is protected by a 0.9-m- (3-ft-) thick, stair-stepped RCC slab. The downstream slab extends to the toe of the dam where a 2.1-m- (7-ft-) deep by 5.5-m- (18-ft-) wide RCC cutoff trench has been constructed. Riprap placed downstream of this trench protects the earthen embankment from erosion (Figure 27).

Work was completed in October 1989 (Figure 28) at an approximate cost of \$958,973. This cost is estimated to be about \$500,000 less than the cost for a structural concrete spillway.

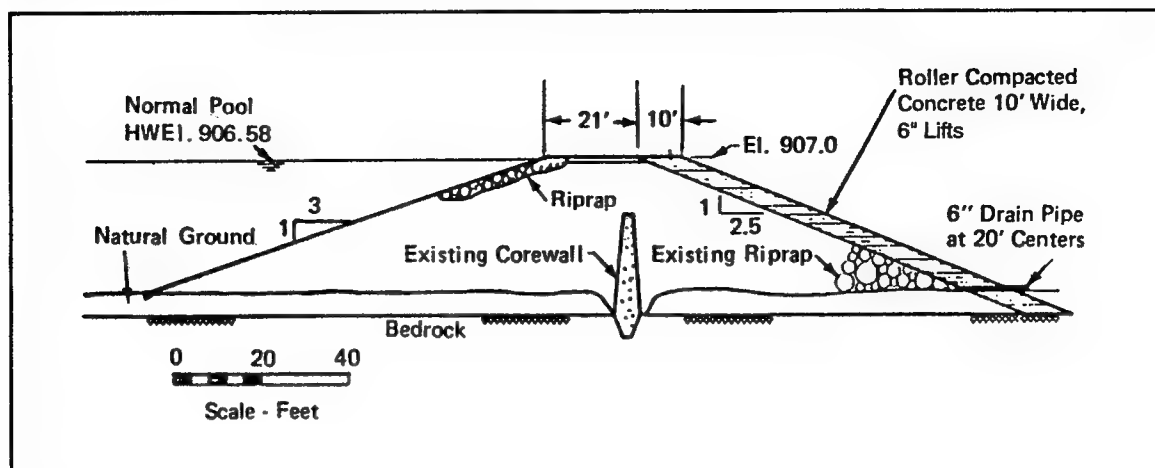
During a routine 5-year safety inspection, the Federal Energy Regulatory Commission (FERC) determined that the discharge capacity of the two spillways — 934 cms (33,000 cfs) — could not handle the calculated PMF peak discharge of 4,163 cms (147,000 cfs). Subsequent analyses indicated that discharges greater than 2,832 cms (100,000 cfs) would produce minimal incremental downstream damage as a result of a dam failure. Therefore, it was concluded that the additional spillway capacity required was about 1,900 cms (67,000 cfs). Four alternative designs were considered to achieve this additional capacity (Marold 1992). Preliminary studies indicated construction of an uncontrolled overflow spillway in the left embankment and protection of the

Figure 29. Cross section of the overflow spillway and RCC embankment protection at Boney Falls Dam (courtesy of Marold 1992, ASCE). (Multiply inches by 25.4 to obtain millimetres and feet by 0.3048 to obtain metres)

downstream side of the embankment with RCC would be the best option for economic and technical reasons (Figure 29).

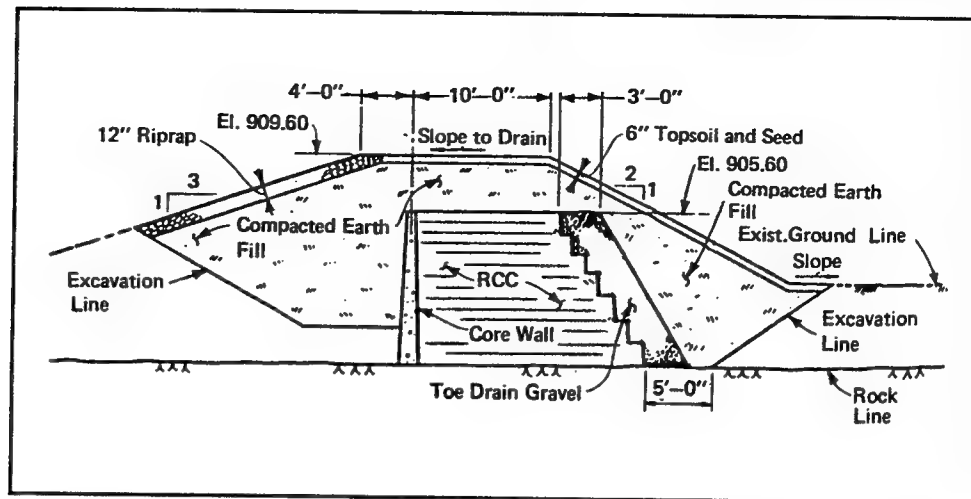
Figure 30. RCC spillway section with erodible earth-fill crest, Boney Falls Dam (courtesy of Marold 1992, ASCE). (Multiply inches by 25.4 to obtain millimetres and feet by 0.3048 to obtain metres)

To avoid a substantial seepage path that was located below the north-south section of the dam, the contractor decided to shorten the spillway section from 304.8 to 152.4 m (1,000 to 500 ft). This change meant the crest of the RCC gravity section had to be lower to carry the same volume as the longer paved RCC designed section. The revised plan called for the crest of the new RCC emergency spillway to be set 0.3 m (1 ft) below normal pool and to be covered with 1.2 m (4 ft) of earth fill, which would serve as an erodible fuse plug. The earth fill over the spillway would wash out when the reservoir water came within 152 mm (6 in.) of the dam crest. The fuse plug would lower the reservoir by only 0.3 m (1 ft) and would require a short reconstruction time were it to wash

out (Marold 1992). The spillway was to be 152 m (500 ft) long, 4.9 m (16 ft) high, 6.4 m (21 ft) wide at the base and 3.4 m (11 ft) wide at the top (Figure 30).

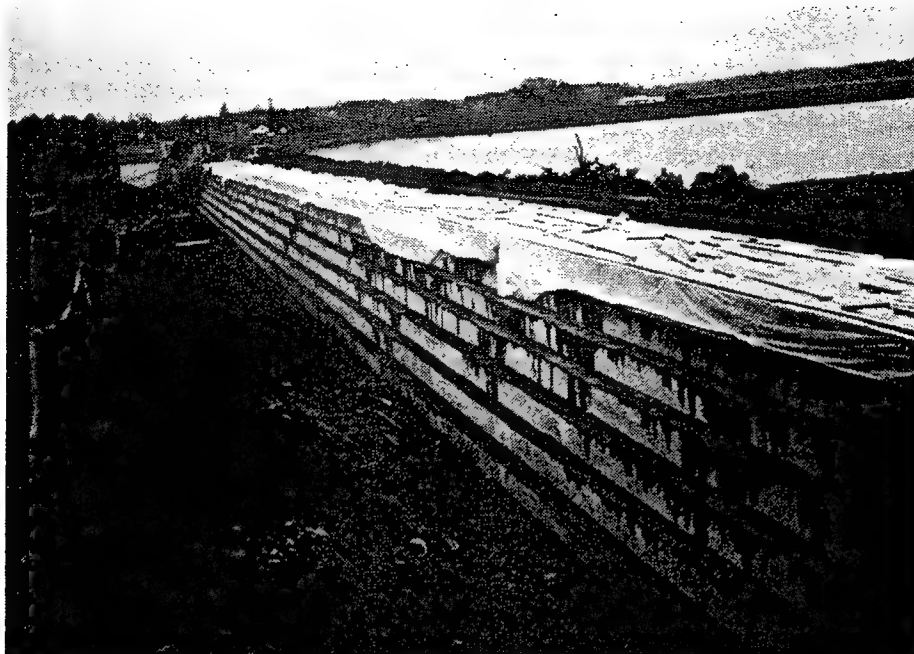
Approximately 1 year after construction, measurements of water levels in three observation wells and measurements of leakage through the gravel drainage layer on the downstream side indicated that the RCC spillway has effectively reduced the headwater across the foundation level by 60 to 100 percent and is performing successfully (Marold 1992). The completed RCC spillway is shown in Figure 32.

Figure 32. The completed RCC emergency spillway at Boney Falls (courtesy of Marold 1992, ASCE)

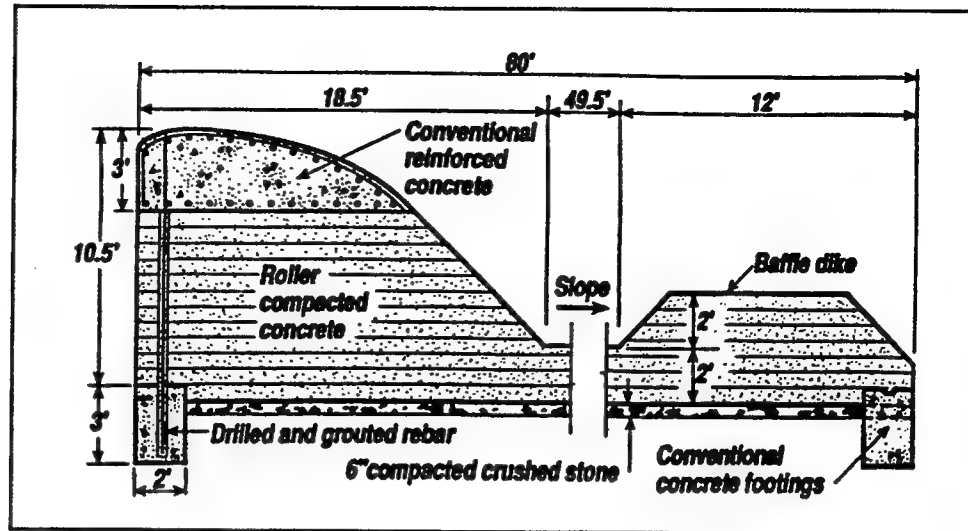
Figure 33. Emergency spillway, Tellico Reservoir Saddle Dam (courtesy of *RCC Newsletter* 1989b)

In 1988-1989, the Tennessee Valley Authority (TVA), as part of its on-going dam safety program, concluded that the saddle dam along the reservoir would be susceptible to overtopping and potential failure in the event of the PMF. To prevent dam failure in such an event, TVA decided to replace part of the saddle dam with an RCC emergency spillway (*RCC Newsletter* 1989b). The new ungated spillway is 609.6 m (2,000 ft) long, 3.2 m (10.5 ft) high, and 2.4 m (80 ft) wide. It has an uncontrolled ogee crest of conventional reinforced concrete and slotted end sills or baffle dikes (Figure 33). The crest elevation is at the approximate level of the PMF. The width of the ogee section is 5.63 m (18.48 ft), and the height of the crest is 4.11 m (13.5 ft) from the bottom of the shear key. A horizontal apron-type energy dissipator extends 18.75 m (61.52 ft) downstream of the ogee section; a 0.6-m-, 76-mm- (2-ft-, 3-in.-) high by 4.3-m- (14-ft-) wide endsill at the downstream end of the apron provides additional energy dissipation. RCC was selected for construction of the apron, endsill, and spillway section.

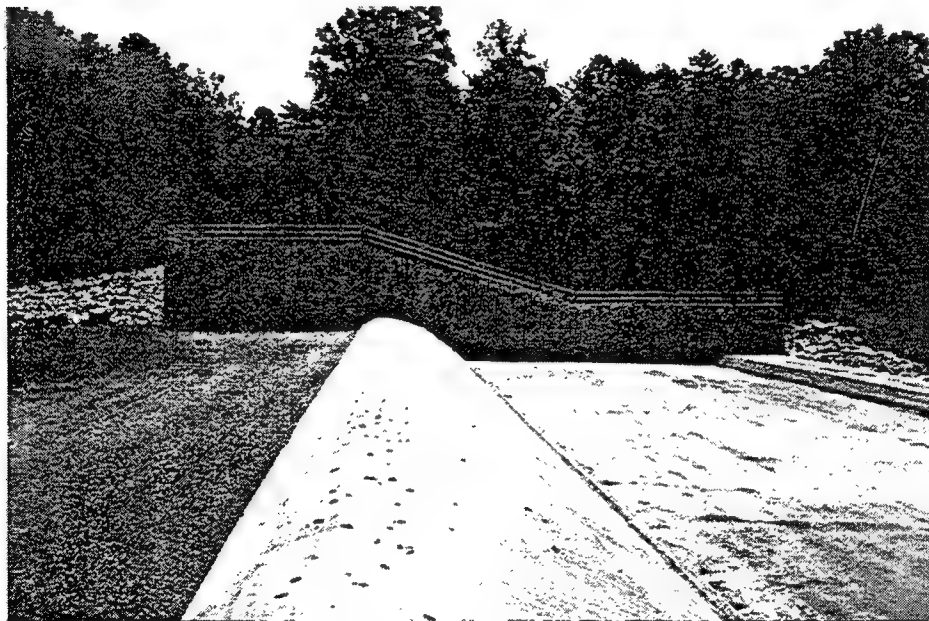
Figure 34. Portion of completed spillway, Tellico Reservoir Saddle Dam

Approximately 15,000 cu m (19,600 cu yd) of RCC was required for the placement which began in October 1988 and was essentially complete in December 1988. Total cost of the RCC, including materials and placement was about \$52/cu m (\$40/cu yd). The completed spillway is shown in Figure 34.

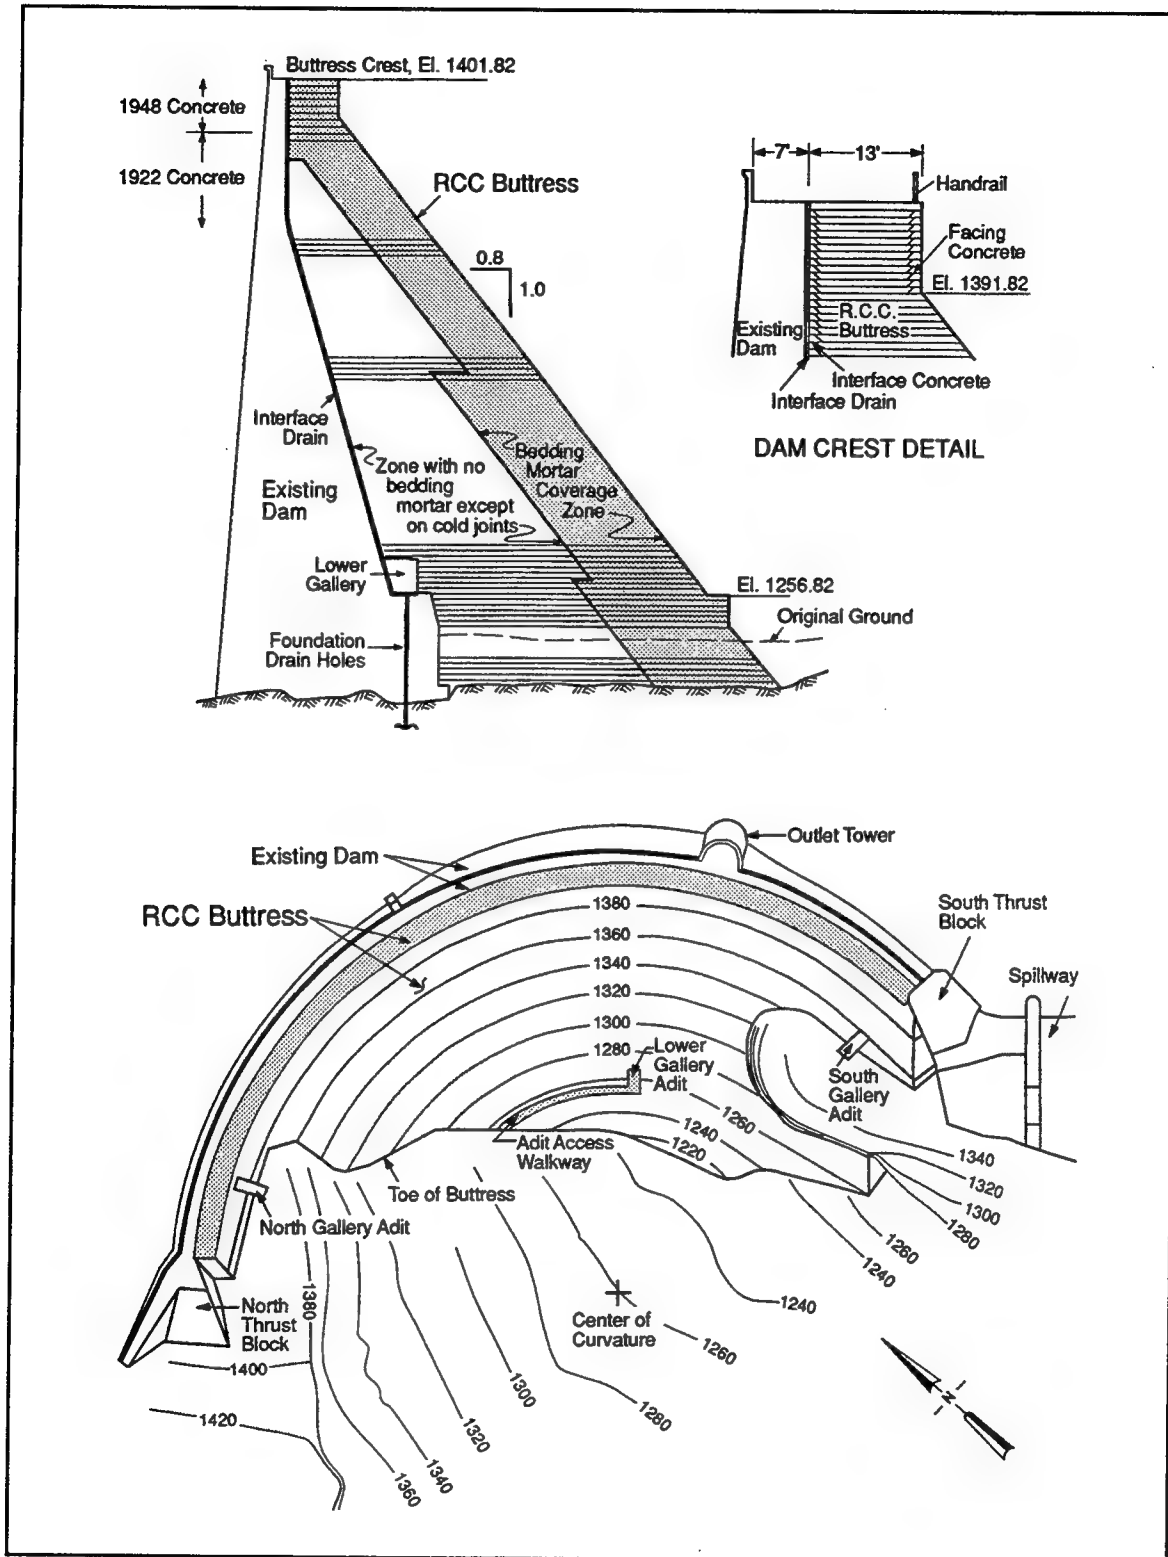
Figure 35. Cross section and plan of RCC buttress, Gibraltar Dam (courtesy of Wong et al. 1992, ASCE)

The RCC buttress increased the width of the dam crest by 4 m (13 ft). The face of the buttress is vertical for the top 3 m (10 ft) and then slopes at 0.8H:1V to the toe (Figure 35). The structural analyses of the RCC buttress were based on the assumption that the strengthened dam will respond to loading as a monolithic structure. Provisions required to ensure adequate bonding between the existing dam and the RCC buttress included sandblasting the downstream face of the existing dam, placement of a zone of conventional concrete at the interface, and installation of interface drainage pipes. A drainage gallery system (Figure 36) was included within the RCC buttress to allow for collection of inflows from the interface drains, foundation drains, and buttress drains and for monitoring and maintenance of the drainage system.

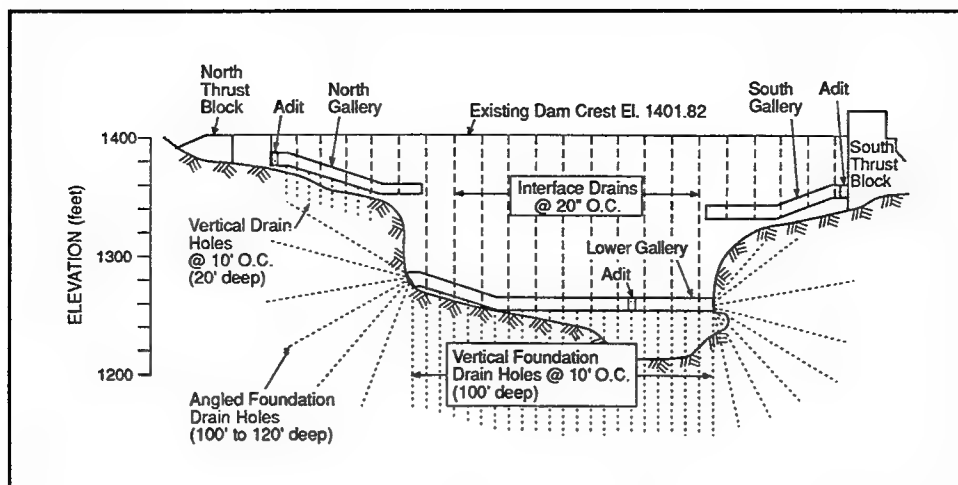
Figure 36. Layout of drainage system, Gibraltar Dam (courtesy of Wong et al. 1992, ASCE). (Multiply feet by 0.3048 to obtain metres)

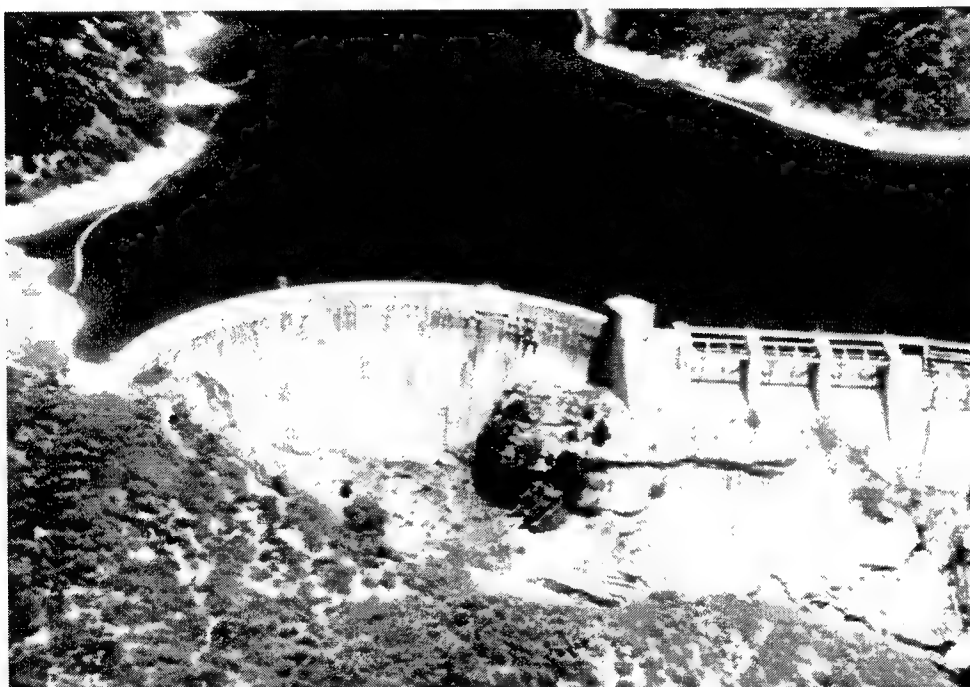
Figure 39. Gibraltar Dam after being strengthened with an RCC buttress (courtesy of Wong et al. 1992, ASCE)

RCC placement rates varied widely, depending on the width of the lift surface. The narrower the lift area, the slower the placement. The best week of RCC production was in early November when 10,630 cu m (13,900 cu yd) was placed in 5 days. Overall, the average production for a 10-hr shift was just over 765 cu m (1,000 cu yd) with a maximum production of 1,321 cu m (1,728 cu yd). A total of 71,100 cu m (93,000 cu yd) of RCC was placed between October 1 and December 22, 1990. The completed project is shown in Figure 39.

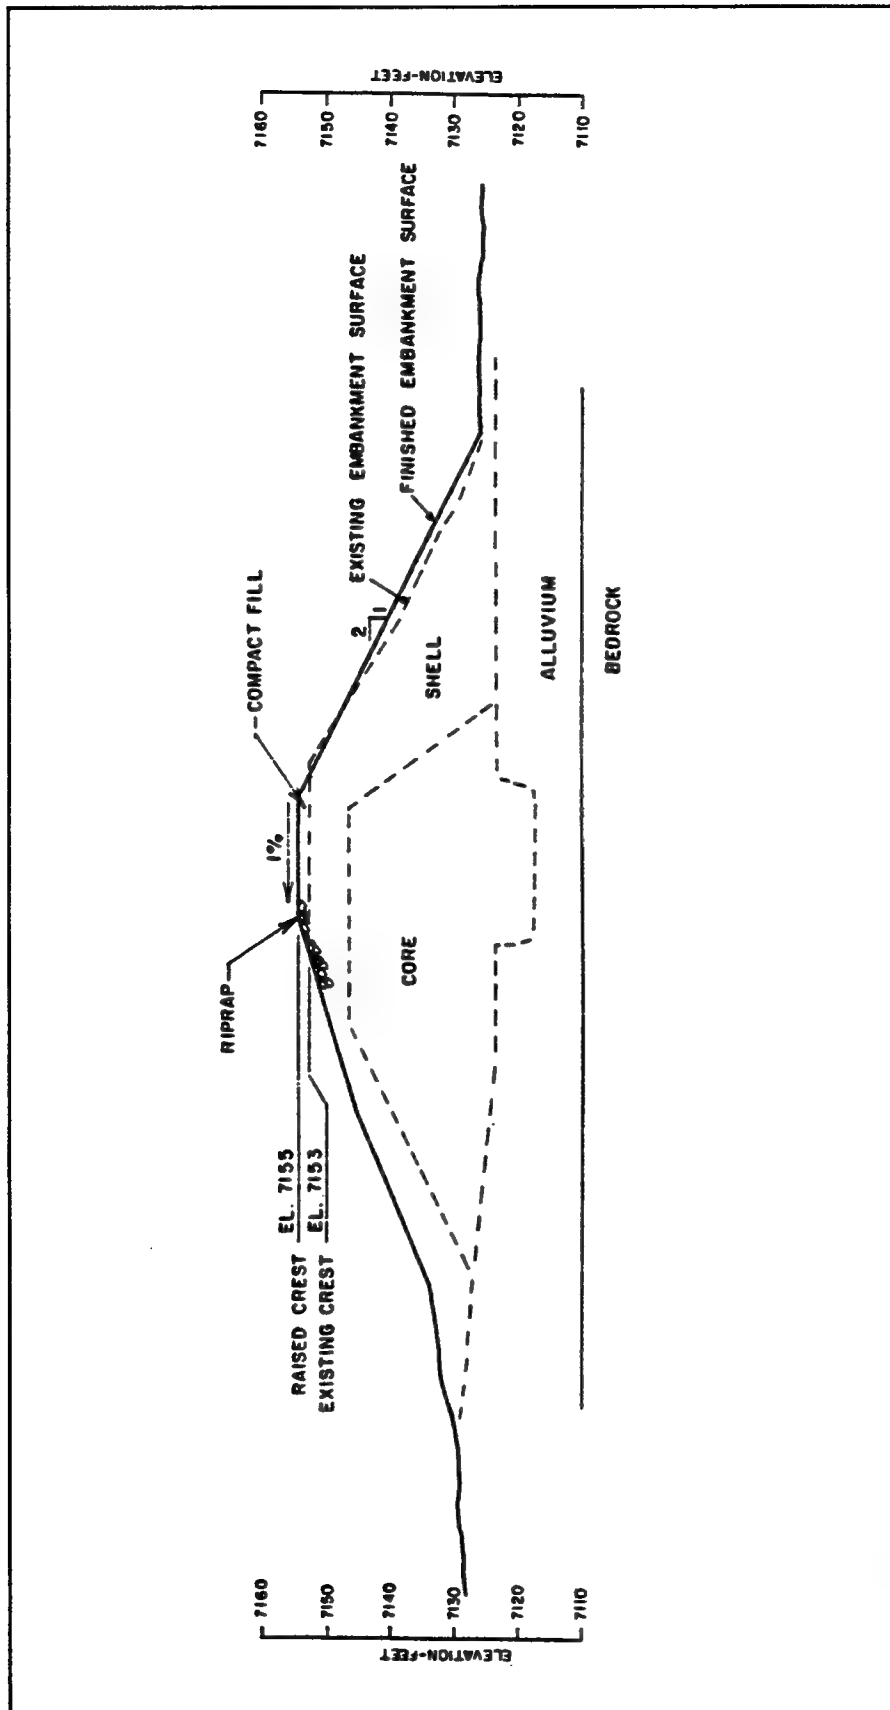
Figure 40. RCC emergency spillway at Kemmerer City Dam (courtesy of Johnson, Locke, and Oritz 1989, ASDSO)

Approximately 3,140 cu m (4,100 cu yd) of RCC was required to construct the emergency spillway in 1990. The unit cost of the RCC, which included 147 kg/cu m (248 lb/cu yd) of cement was \$98.17/cu m (\$75.06/cu yd).

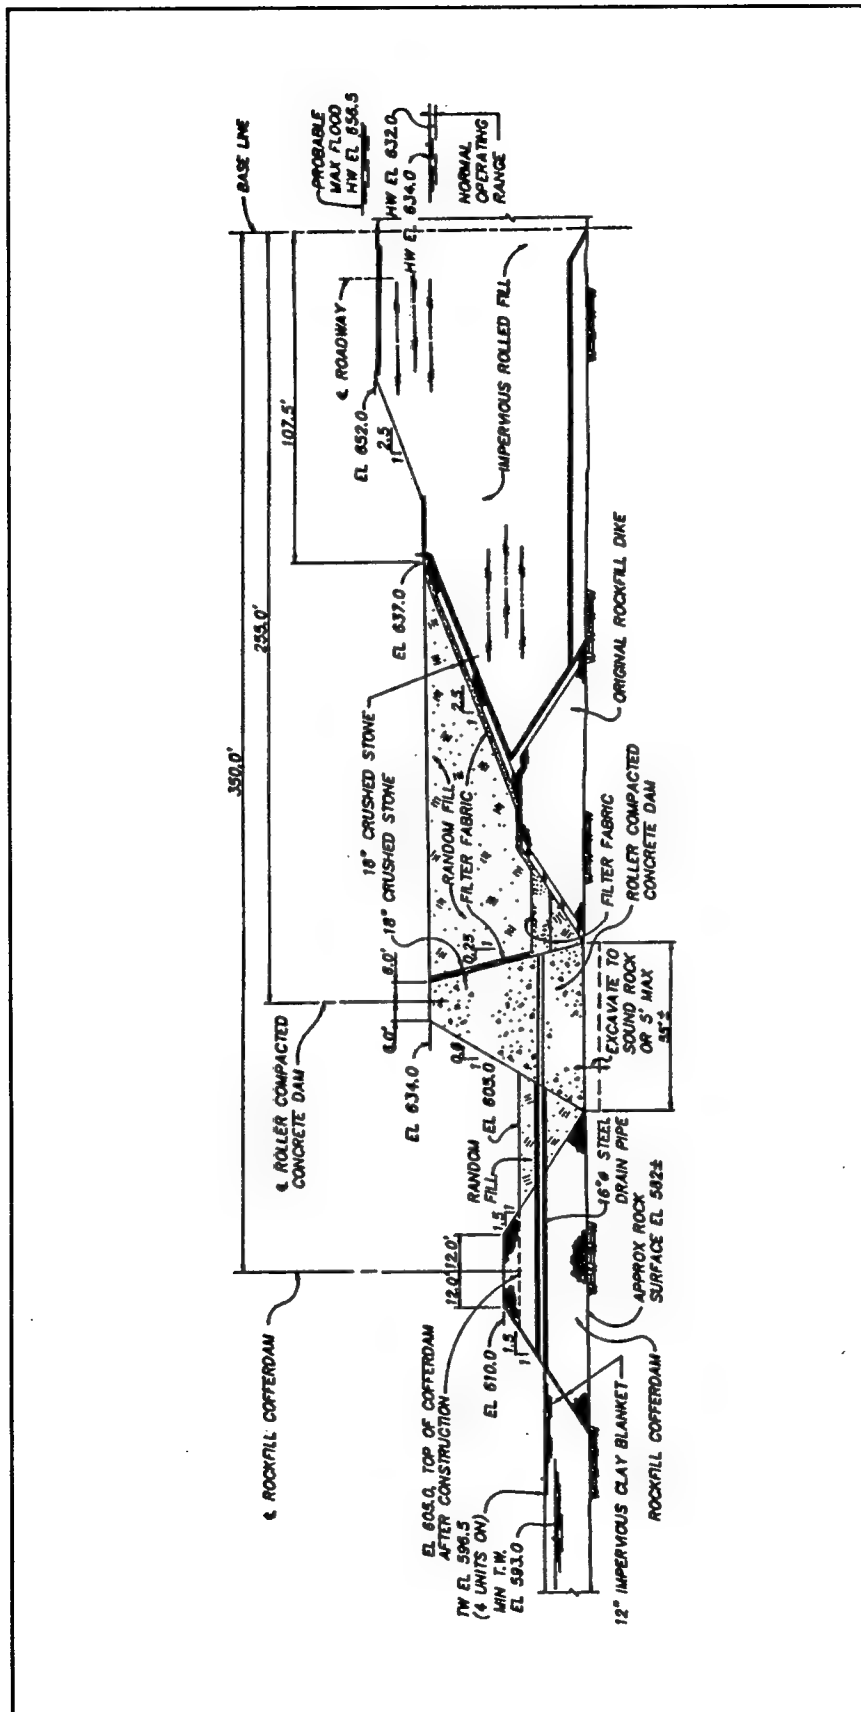
Figure 41. Right embankment modifications, Nickajack Dam (courtesy of Newell, Manson, and Wagner 1991, ASCE). (Multiply feet by 0.3048 to obtain metres and inches by 25.4 to obtain millimetres)

A decision was made to construct an RCC dam downstream of the north embankment (Figure 41) and to increase the height of the south embankment. During extreme floods, the north embankment would overflow and erode to the top of the RCC dam. The RCC dam would become an emergency spillway that would maintain the normal maximum pool in the reservoir (Newell, Manson, and Wagner 1991).

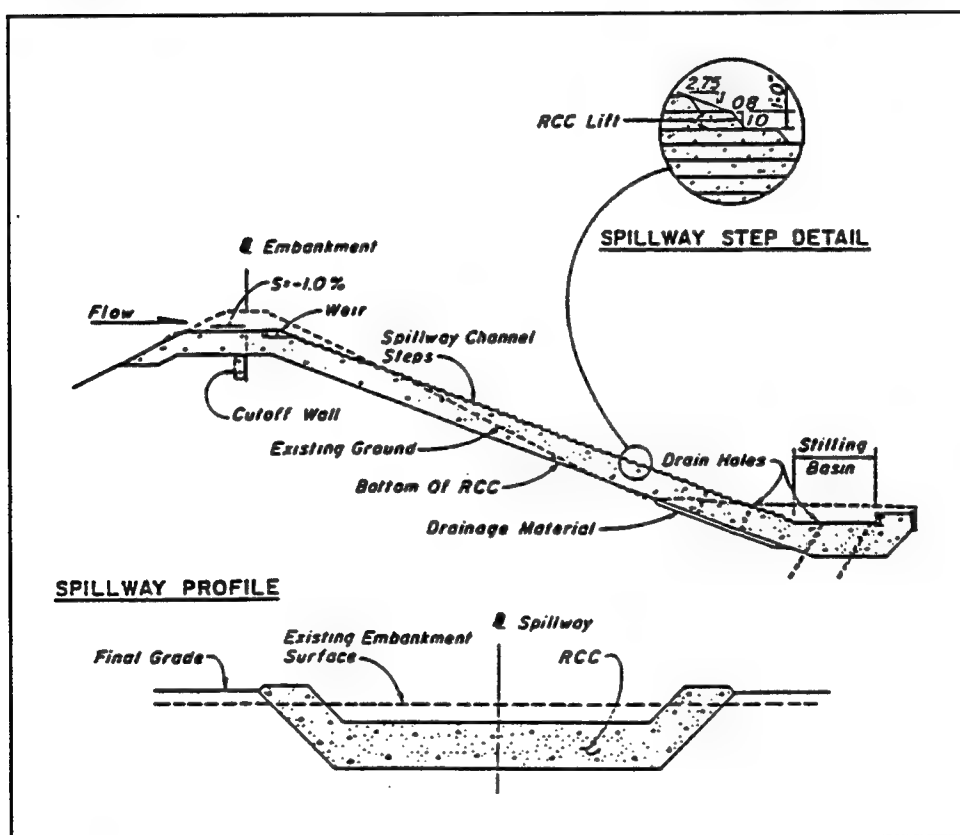
Figure 49. Spillway profile and section, Ringtown No. 5 Dam

The RCC alternative consisted of a 76.8-m- (252-ft-) long, trapezoidal-shaped spillway and stilling basin. The RCC alternative did not require a reduction in the normal operating level of the reservoir because of its wide crest geometry which was attained by constructing the spillway on the embankment. Based on the low bid for the project, the cost of the RCC spillway was about \$500,000 or approximately 40 percent of the total construction cost. The low bid for the RCC, which included furnishing the aggregate, cement, and pozzolan and batching and conveying, was approximately \$291,000 or \$60/cu m (\$46/cu yd). The RCC alternative (Figure 49) was selected because it would not affect reservoir capacity, it was more economical, and the stepped profile would aid in energy dissipation.

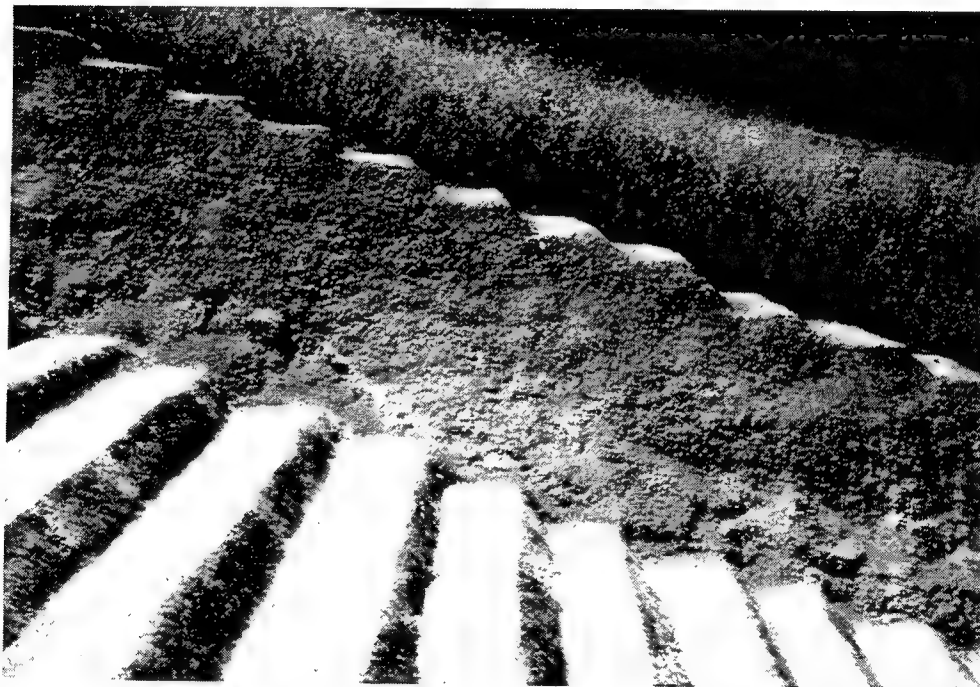
Figure 52. Completed steps and wall, Ringtown No. 5 Dam

The RCC for the steps was overlaid and compacted approximately 0.3 m (1 ft) beyond the proposed step location. The excess material was trimmed to the required 0.8H:0.1V slope (Figures 51 and 52). The trimmed material was mixed into the succeeding lift. The walls were trimmed to a final slope of 1H:1V.

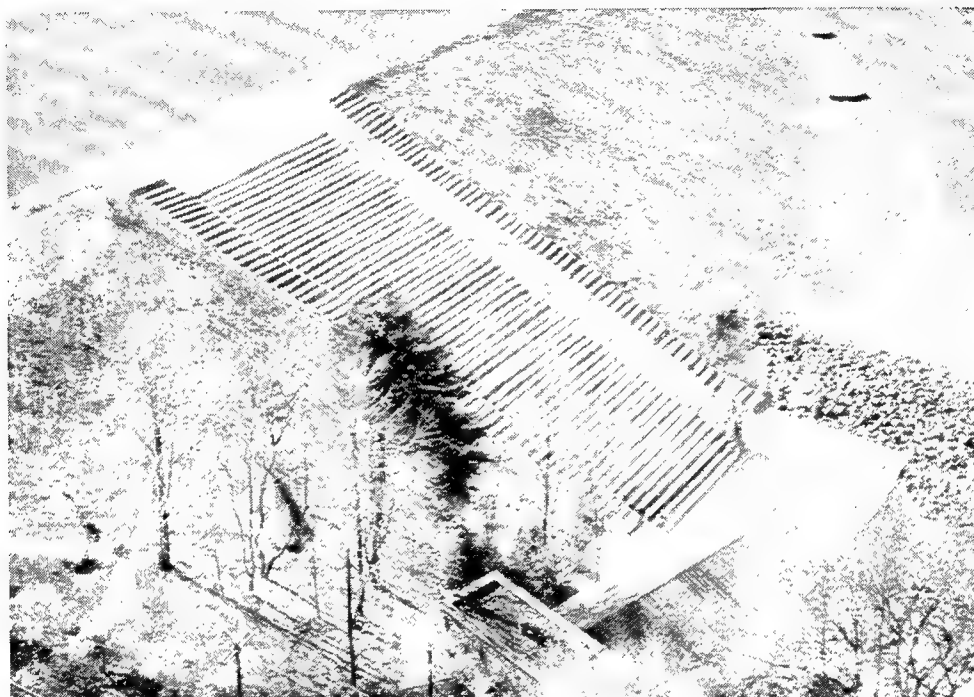
Figure 53. Completed spillway, Ringtown No. 5 Dam

Quality control consisted of visual inspection and density and strength testing of RCC cylinders. Visual observations were made to check moisture content of the material as it was conveyed from the batch plant. The densities of cylinders cast for testing were compared with those measured with a nuclear density gage, and very good agreement was obtained. Strength tests on the cylinders indicated an average compressive strength of 24.5 MPa (3,560 psi) at 90 days. The completed spillway is shown in Figure 53.

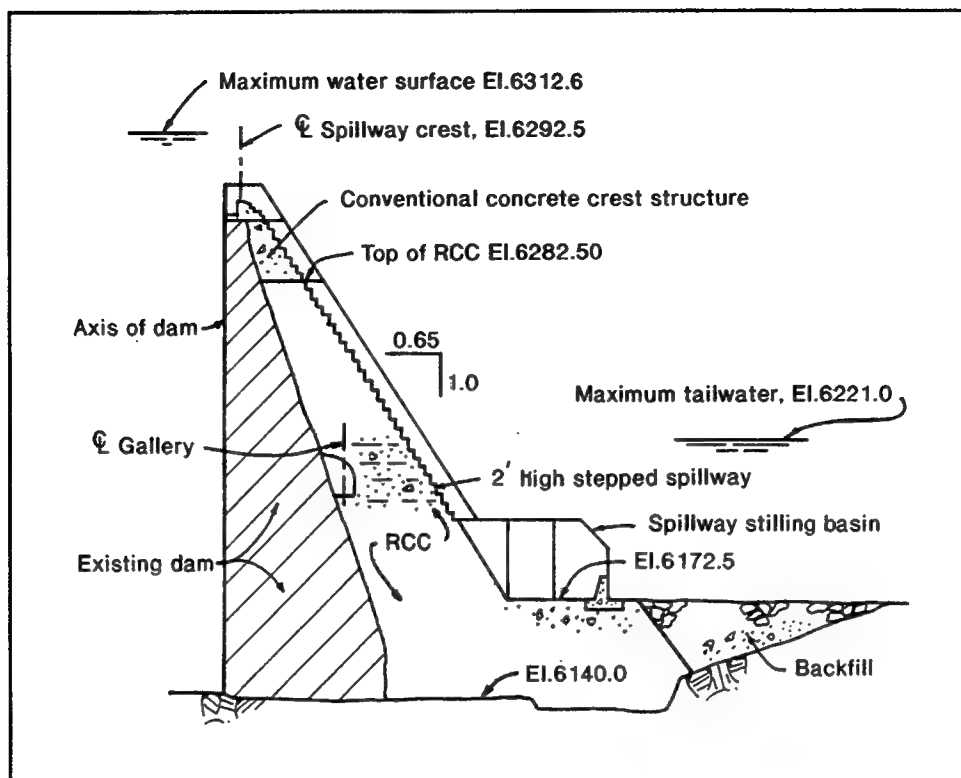
Figure 54. Section showing original Santa Cruz Dam and modifications (courtesy of Metcalf, Dolen, and Hendricks 1992, ASCE)

An RCC buttress at the downstream face of the dam (Figure 54) was designed to reinforce the entire dam from the foundation to within 6.1 m (20 ft) of the crest. Also, the buttress was designed to provide erosion protection to both abutments in the event of dam overtopping. A stepped-chute conventional concrete spillway was incorporated into the RCC buttress. The spillway chute converges from 22.9 m (75 ft) wide at the uncontrolled ogee crest to 16.2 m (53 ft) wide at the stilling basin 36.6 m (120 ft) below (Metcalf, Dolen, Hendricks 1992).

Strength requirements for the RCC mixture were based on MCE loading conditions. The RCC was proportioned to have a compressive strength of 20.7 MPa (3,000 psi) at 1 year, cohesion of 0.34 MPa (50 psi) at 1 year (new to old concrete), and freeze-thaw durability (minimum of 500 cycles). An AEA was

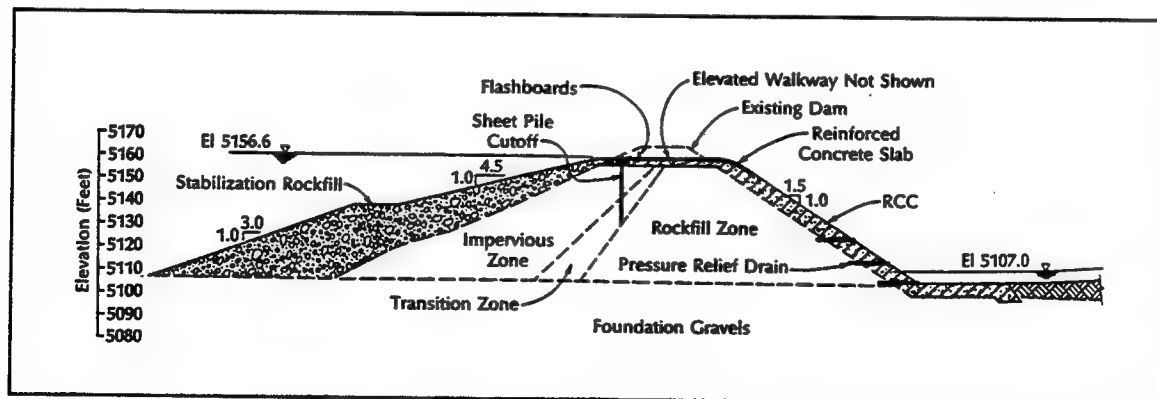
Figure 56. Cross section of Ashton Dam (courtesy of Froehlich and Nigus 1991, ASCE).  
(Multiply feet by 0.3048 to obtain metres)

Two approaches were considered for passing the PMF flow. One approach would pass the flow without raising the level of the reservoir above the existing dam crest, whereas the other approach would allow the pool level to rise above the crest. Six options including a wide variety of materials were evaluated for each approach. The most cost effective alternative was to protect the crest and downstream slope of the existing dam with RCC and allow the dam to be overtopped in the event of the PMF (Figure 56). FERC staff approved the design and allowed for a maximum overtopping height of 3.7 m (12 ft) in conjunction with a maximum unit discharge of 3.5 cms (122 cfs) per foot of spillway crest.

The crest of the new dam overflow spillway is approximately 61 m (200 ft) long, extending from the west spillway training wall to the powerhouse. The RCC spillway crest, 1.5 m (5 ft) below the original crest of the existing dam, was

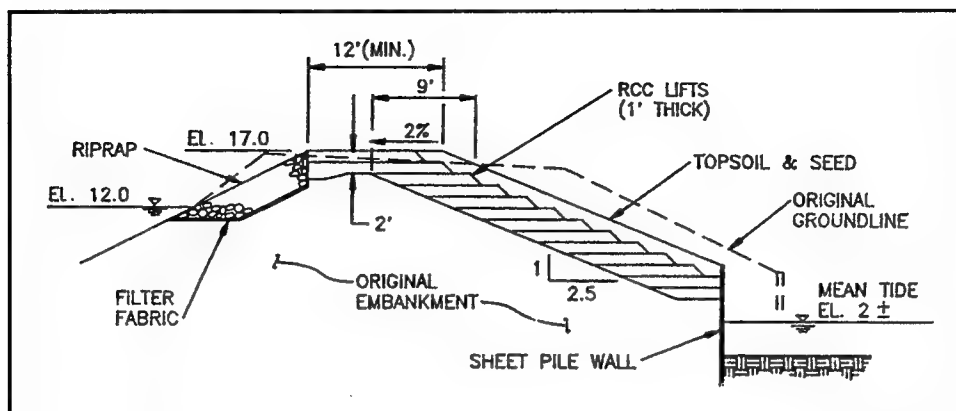
Figure 58. Rehabilitation plan for Lake Lenape Dam (courtesy of Ditchey 1992, ASCE). (Multiply feet by 0.3048 to obtain metres)

A 1988 report prepared by an engineering company hired to rehabilitate the dam cited a number of deficiencies at the dam (Ditchey 1992). The report was based on a review of the Corps of Engineers Phase I Report plus visual inspection, topographic survey, subsurface investigations, a laboratory testing program, and engineering analyses. The investigations revealed that embankments were overgrown with trees and brush and were eroded in some sections, the majority of the slopes did not meet minimum required slope stability, upstream riprap slope protection was inadequate, the crest elevation of some sections of the dam was at 4.7 m (15.5 ft) (design elevation was 5.2 m (17.0 ft)), the spillway did not meet minimum stability requirements, the spillway discharge capacity was only 25 percent of the PMF, and low-level outlet gates and operators were in varying stages of disrepair.

The rehabilitation plan specified placing the RCC in 0.3-m- (1-ft-) thick horizontal lifts with a stepped downstream slope of 2.5H:1V (Figure 58). Site restrictions prevented construction of an apron at the downstream toe to provide
